REPORT NUMBER: 3083303SAT - 001 REV1
ORIGINAL ISSUE DATE: February 20, 2008
REVISION DATE: January 5, 2009

PRODUCT EVALUATED: 4' x 8' and 4' x 14' Single Panel PSM80 Wall Systems

EVALUATION PROPERTY: ICC – AC 15, Section 4.2.2.2, ASTM E 72 - 05, Section 9 (**Compressive Load**)

TEST REPORT

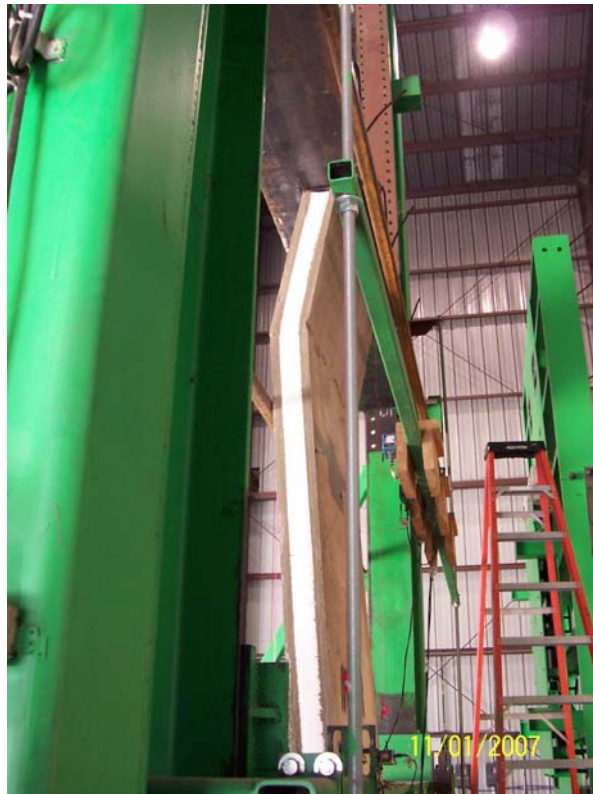
ULTIMATE FAILURE DATA				
850	126090	31523	Ultimate	<p align="center">Panel Failure</p> <p>Wall failed approximately 26 seconds into 6th target load Some mortar debris began to fall off top of wall 3 to 5 seconds before failure Shear failure at top of wall, approximately 27" down from the top Complete horizontal shear break all along panel 4' width in direction of eccentric load No other visible damage present on wall</p>

Figure 4A: 4X8A1 Failure mode

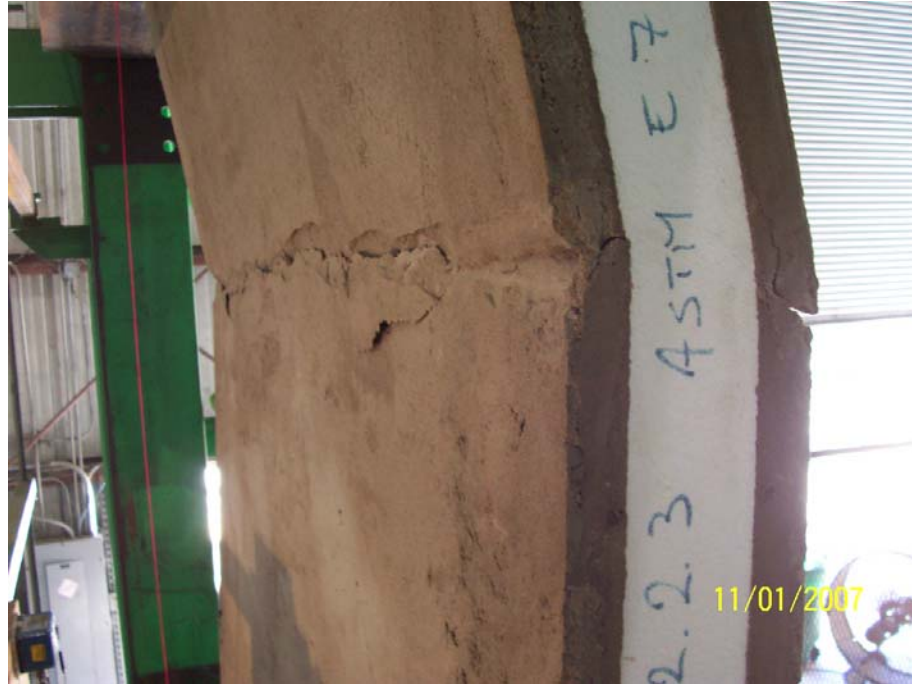
Figure 5A: 4X8A1 Failure mode (close-up)

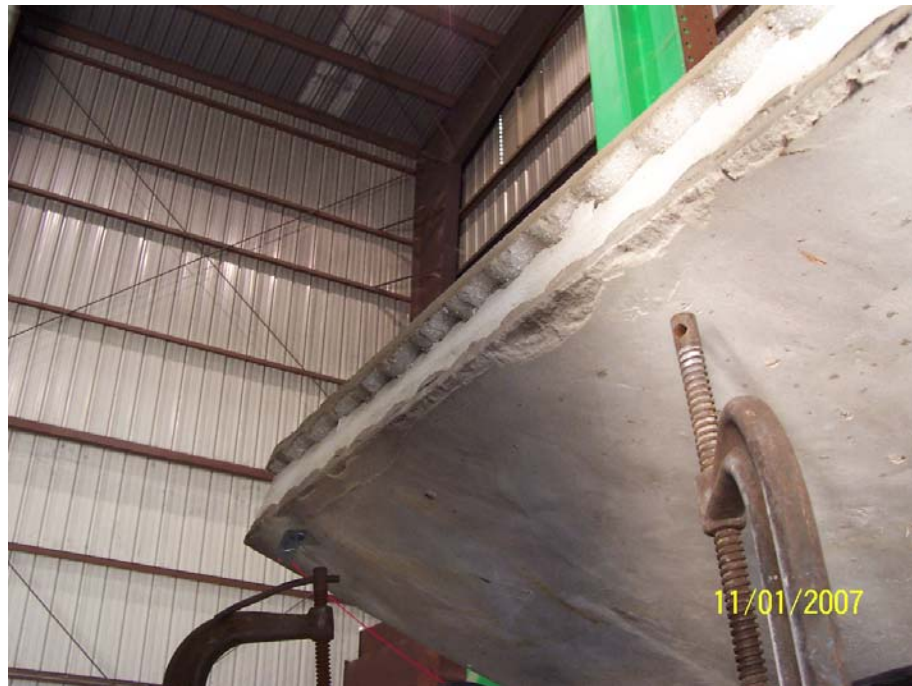
Figure 6A: 4X8A1 Failure mode (close-up at top)

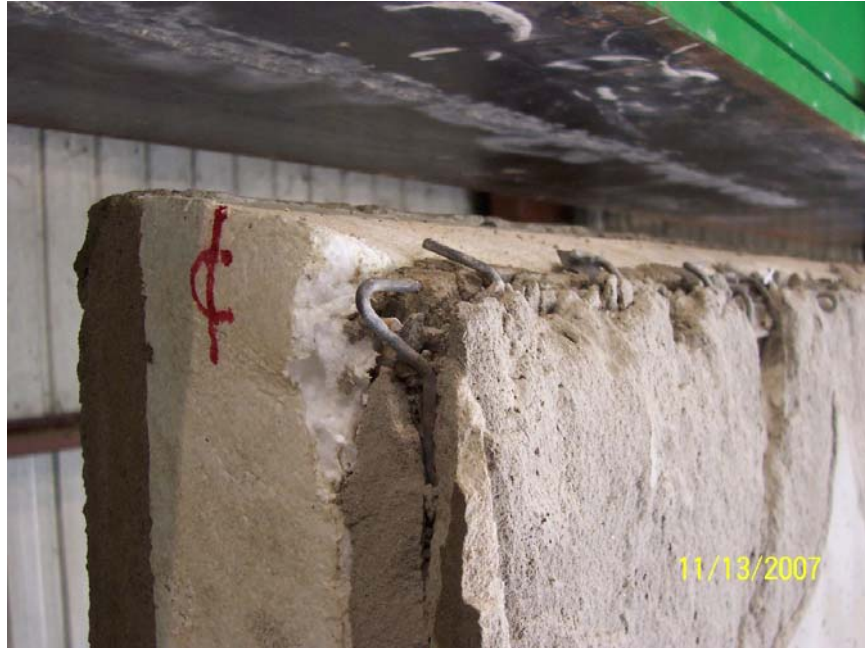
ULTIMATE FAILURE DATA				
280	40110	10028	Hold 2 min	No change, no visible damage
360	51070	12768	Hold 2 min	Small piece of mortar fell off from top-rear side, no additional visible damage
390	55750	13938	Hold 2 min	Additional mortar debris falling off from top, no additional visible damage
420	60610	15153	Hold 2 min	Mortar debris falling from front side
450	65220	16305	Hold 2 min	No change, no visible damage
470	70110	17528	Hold 2 min	Additional mortar debris falling off from top, no additional visible damage
520	75100	18775	Hold 2 min	Additional mortar debris falling off from top, no additional visible damage
550	80700	20175	Hold 2 min	Panel deflecting more in direction of eccentric load
580	85370	21343	Hold 2 min	Additional mortar debris falling off from top, no additional visible damage
620	90260	22565	Hold 2 min	Mortar debris falling from both sides, no additional visible damage
650	95250	23813	Ultimate	Panel Failure Wall began to make popping and cracking sounds while holding load. Failure occurred 1:40 seconds into holding load. Even distribution of crushing at top-rear (compression side) throughout entire wall width. Slight curvature visible at top in direction of eccentric load. Minimal crushing visible at bottom of wall. Second layer of mortar sheared off at top, with the majority of the shear located at top-rear of wall. No additional visible damage present

Figure 10A: 4X14A1 Failure mode at top of wall

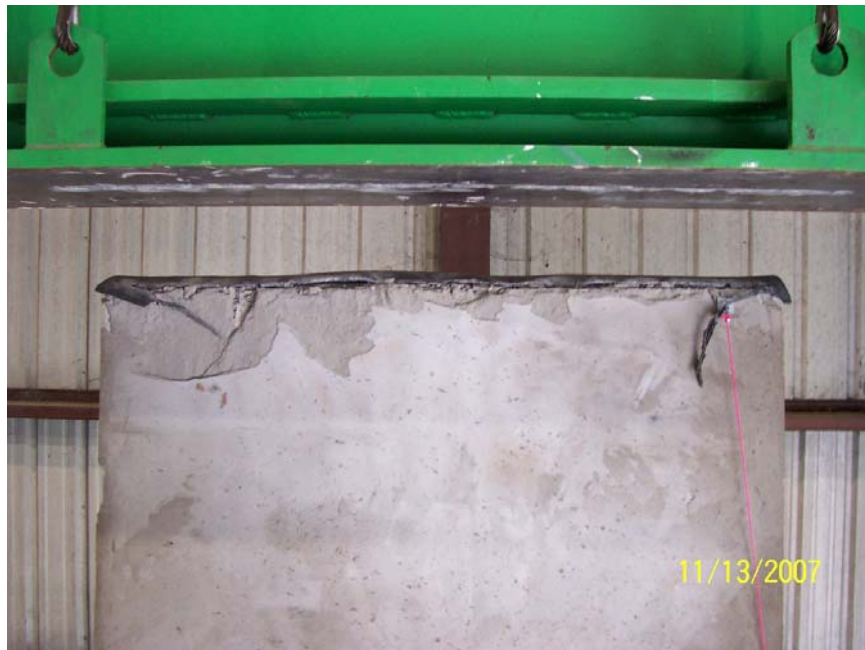
Figure 11A: Rear view of failure mode
